Hamilton City Hall: The Changing Face of Business / Heritage

Adaptation and Reinvention:
Technical / Adaptive Solutions for Large
Projects

Heritage Canada The National Trust
Conference
Charlottetown, Prince Edward Island
October 4, 2014

Paul Sapounzi
+VG Architects

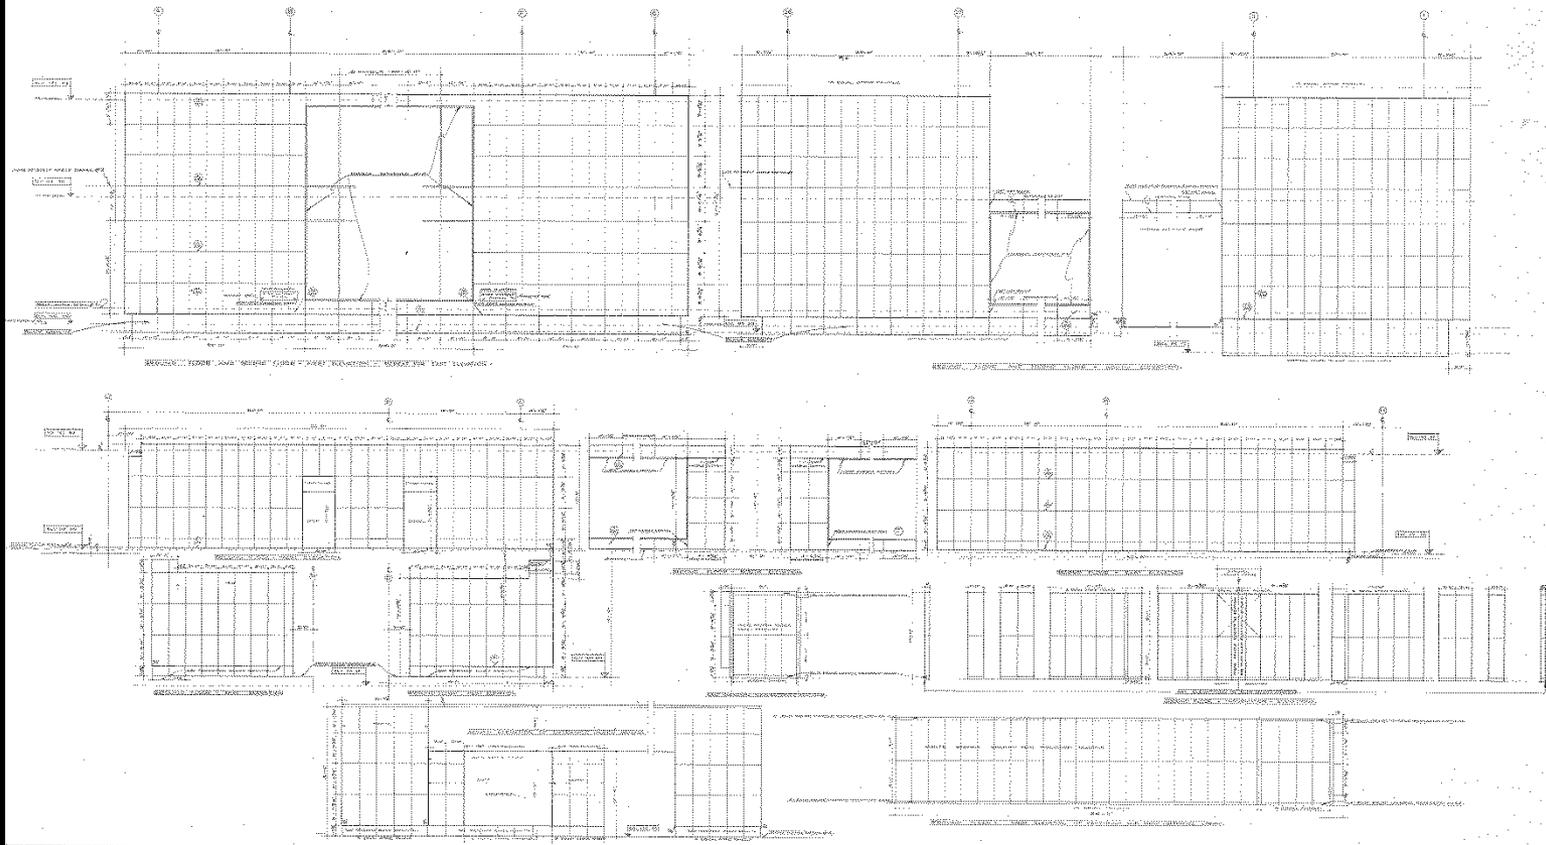
Stone patterns, S.M. Roscoe, 1958

Marble cladding

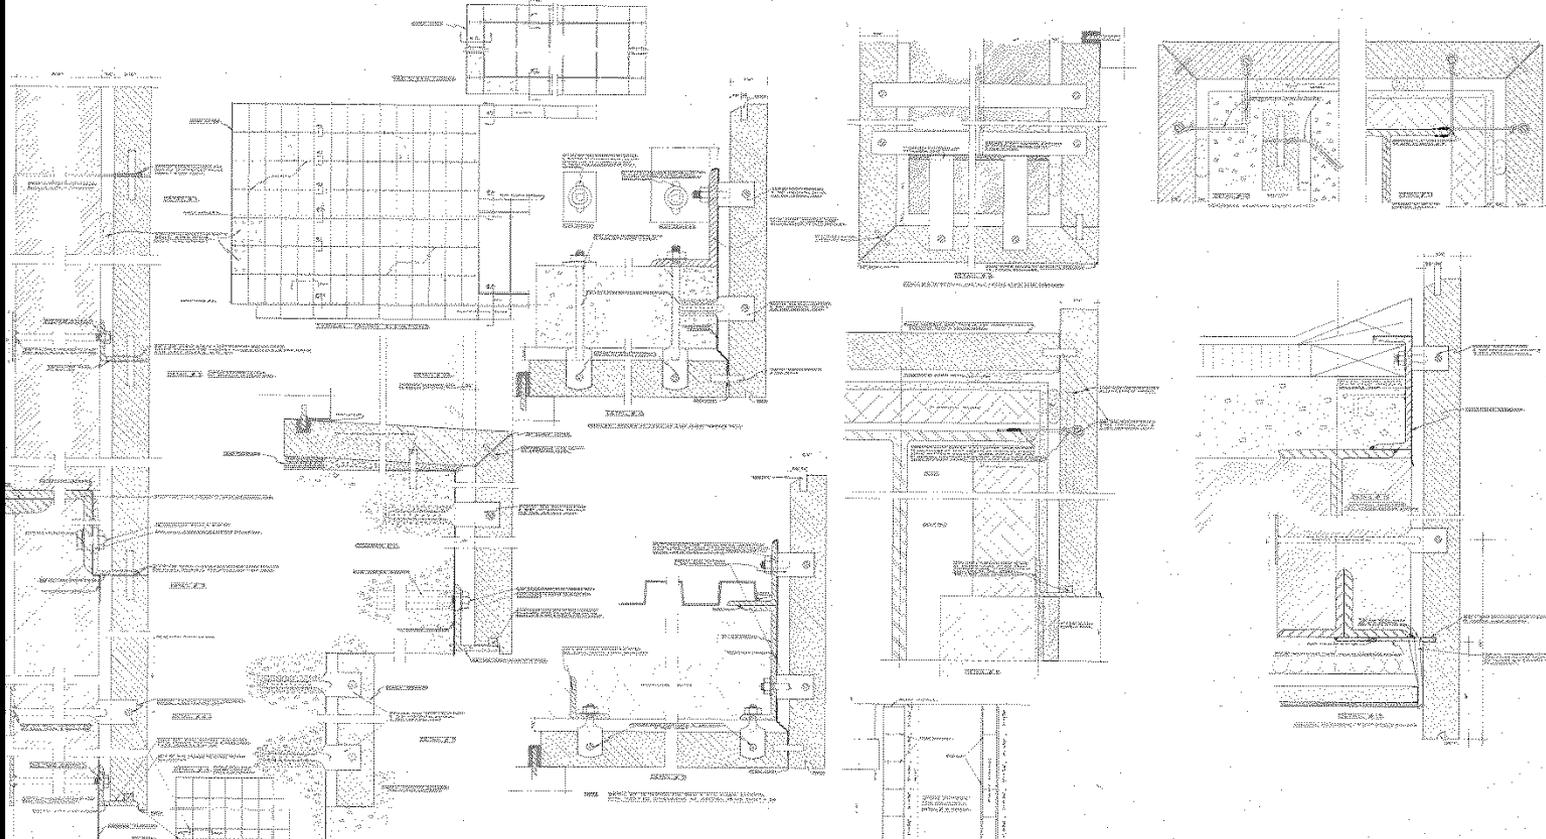
Stone fixings and anchors details, S.M. Roscoe, 1958

Marble cladding

The original anchors for the marble panels started to fail within the first few years of being constructed (early 1960s).

Additional anchors were added to the façade by drilling through the marble panels and patching the exterior.

Further to this remediation, the marble panels started to crack and to bow on the façade.

A building science engineer was involved with the project to specifically look at the marble panels and assess their structural stability. It was determined the panels required replacement.

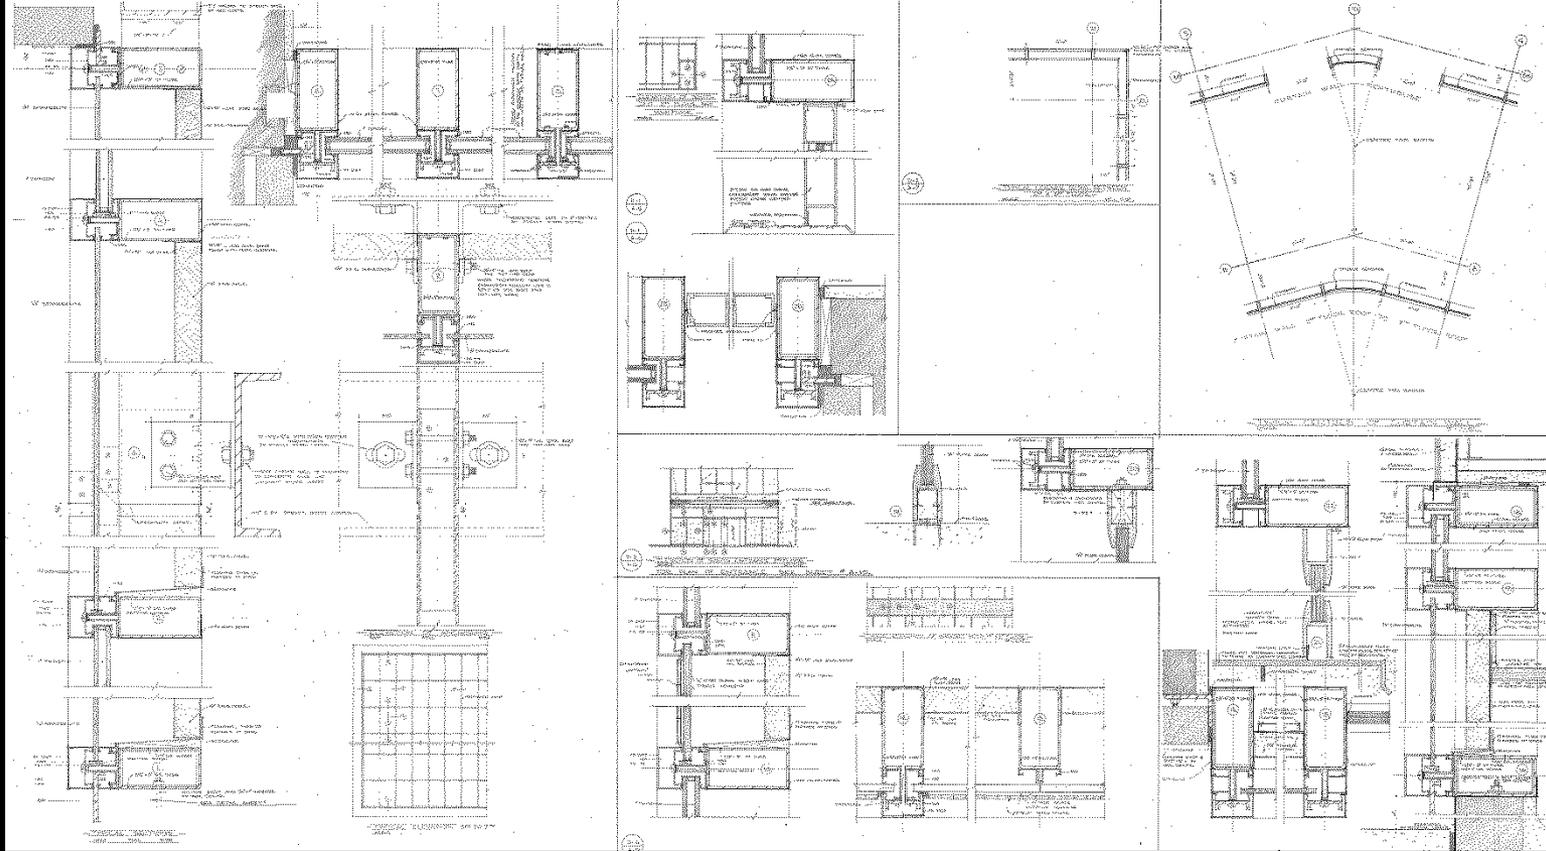
Curtain wall details, S.M. Roscoe, 1958

Curtain wall details

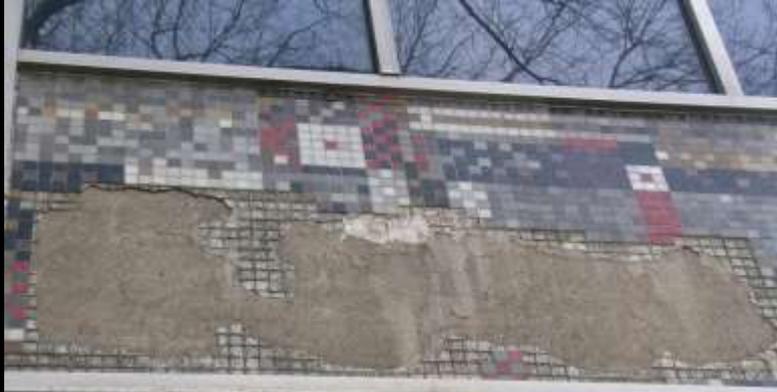
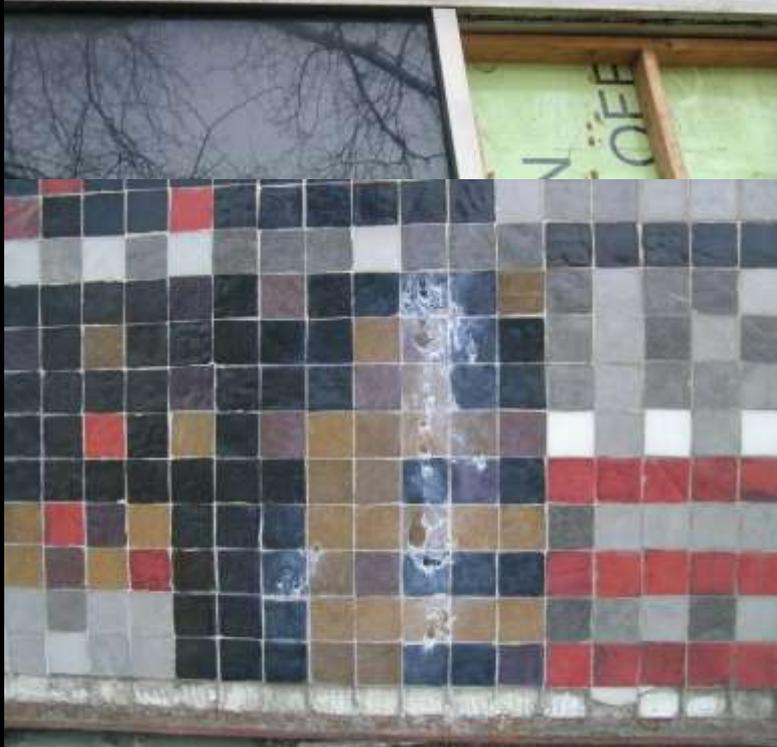
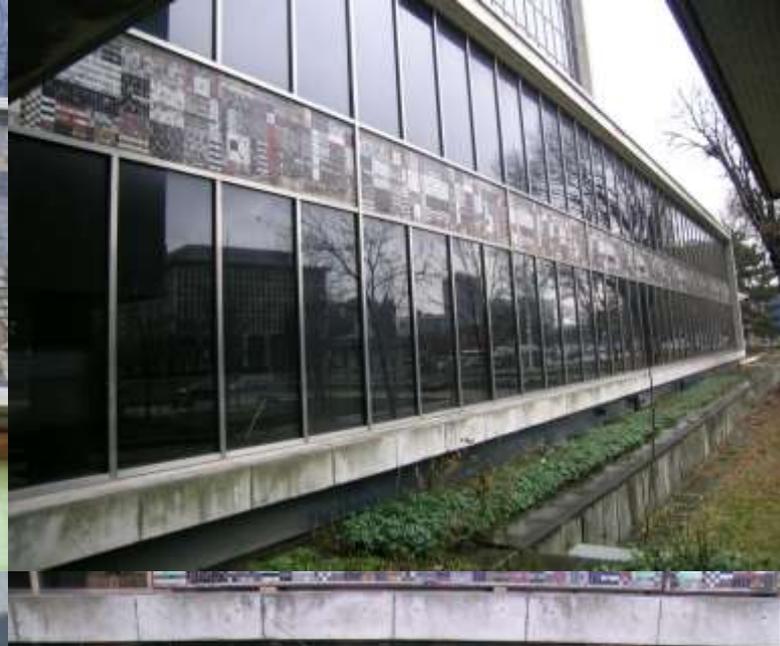
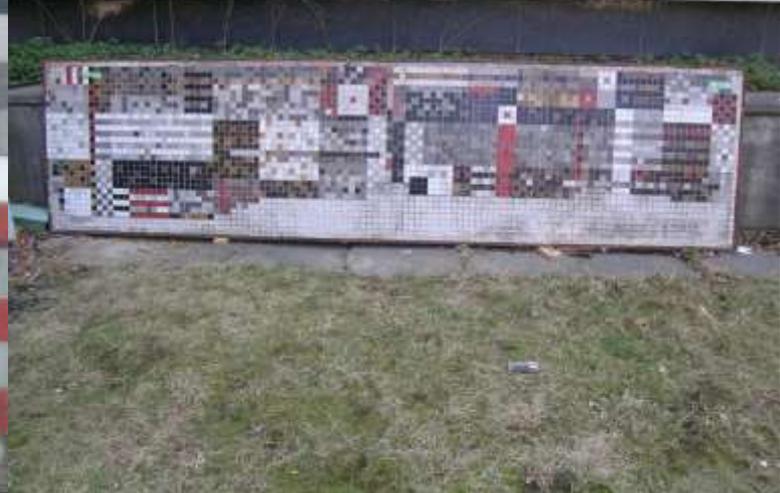
Italian mosaic glass tiles – spandrel panels

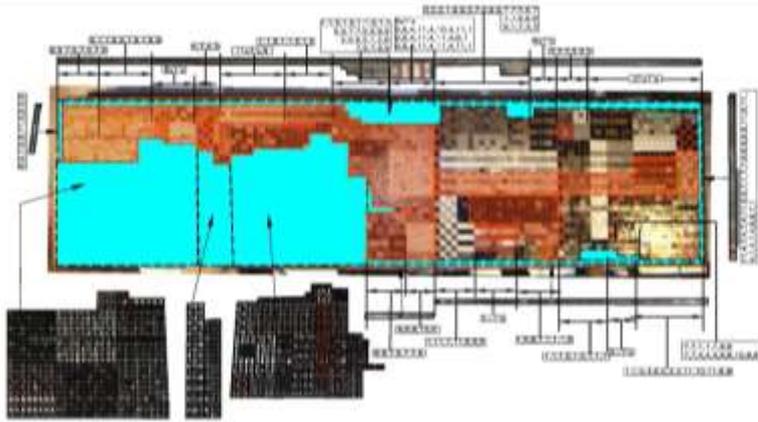
1. 100 - ON NORTH 2
41A 975

1. CAREFULLY CUT OUT AND REMOVE REMAINING PORTLAND CEMENT TILE. REMOVE ALL GROUT AND DETERMINED BASE PLASTER BEHIND THIS AREA. INSTALL NEW PLASTER LEVELING OVER THIS REMOVAL, EXPOSED TILE AND REPLACE REMAINING TILE TO MATCH ORIGINAL TILE COLOR PATTERN.
2. CAREFULLY REMOVE REMAINING LIME TILE AT ISOLATED SPOTS FOR AN APPROXIMATE TOTAL OF ONE (1) SQ. YD. OF GROUT PANEL. REMOVE REMAINING GROUT AND DETERMINED PLASTER. INSTALL NEW PLASTER LEVELING OVER THIS REMOVAL, TILE TO MATCH ORIGINAL TILE COLOR PATTERN.
3. CAREFULLY CUT OUT PATCHES WHERE BEST AT ISOLATED PLASTER AREAS. REMOVE ALL GROUT IN STEEL SUPPORT FRAMING OVER MURAL SURROUNDING PATCH OVER STEEL. INSTALL NEW TYPED SANDWICH MESH PLASTER OVER THIS AREA, NEW PLASTER BASE COAT & LEVELING COAT.

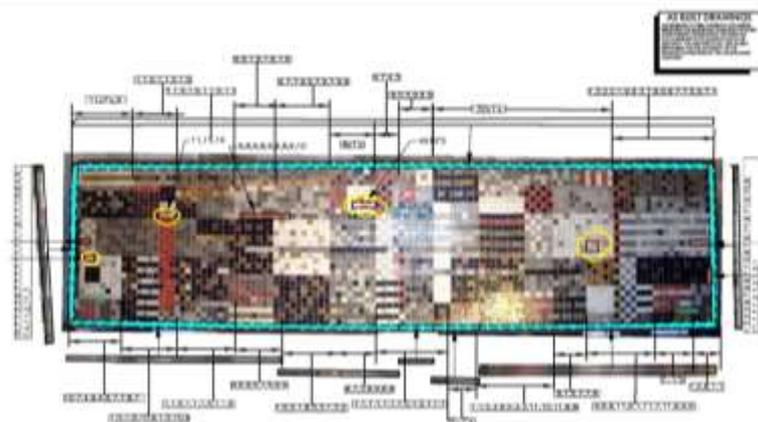
2. 100 - ON NORTH 2
41A 975

1. CAREFULLY CUT OUT AND REMOVE REMAINING PORTLAND CEMENT TILE. REMOVE ALL GROUT AND DETERMINED BASE PLASTER BEHIND THIS AREA. INSTALL NEW PLASTER LEVELING OVER THIS REMOVAL, EXPOSED TILE AND REPLACE REMAINING TILE TO MATCH ORIGINAL TILE COLOR PATTERN.
2. CAREFULLY REMOVE APPROXIMATELY 8 SQUARE FEET OF REMAINING TILE. REMOVE ALL REMAINING GROUT AND DETERMINED BASE PLASTER. INSTALL NEW PLASTER LEVELING OVER THIS REMOVAL, TILE TO MATCH ORIGINAL TILE COLOR PATTERN.

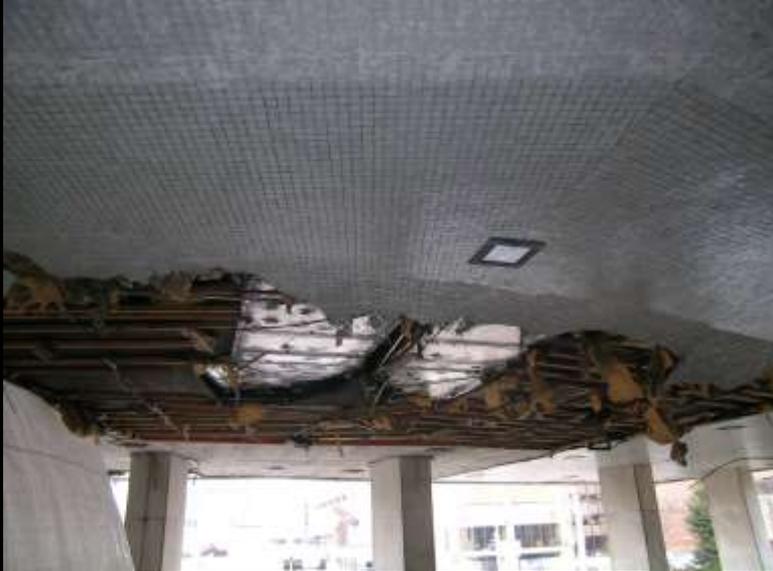
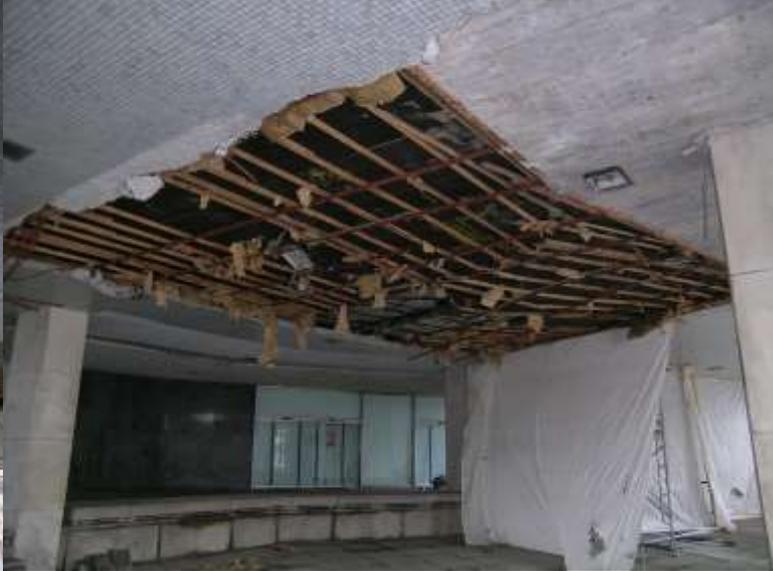
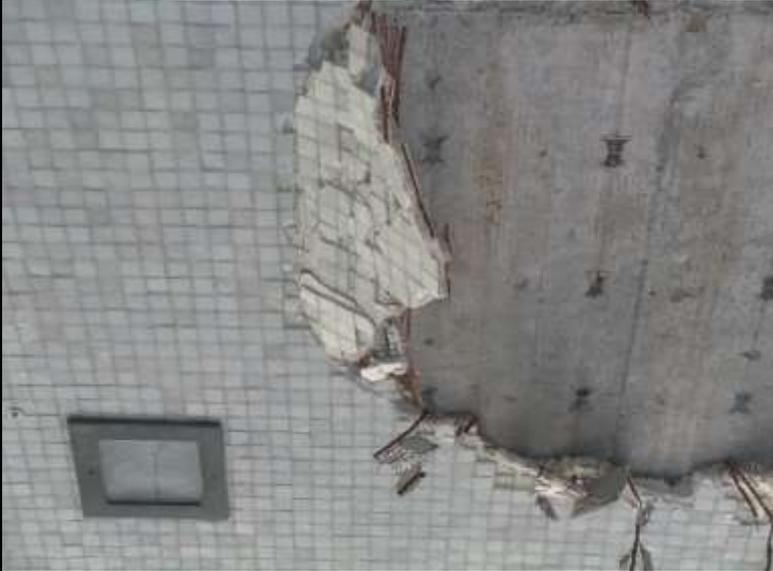
Italian mosaic glass tiles – soffit

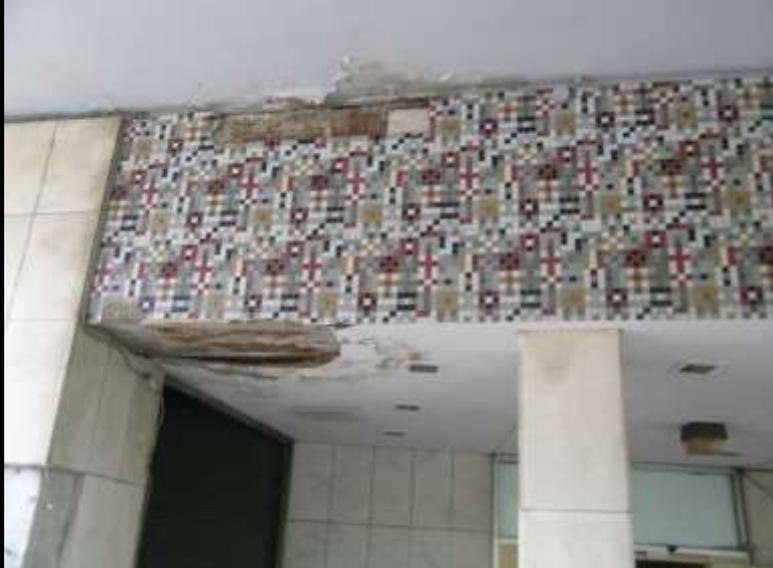
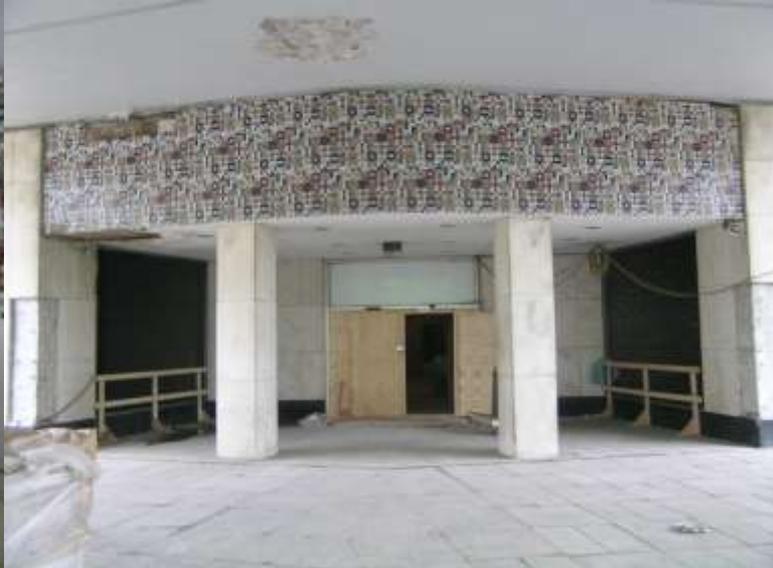
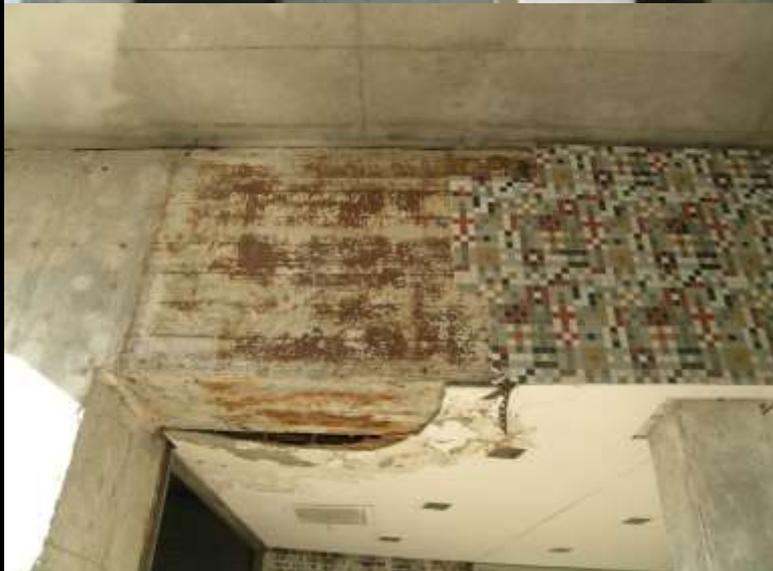
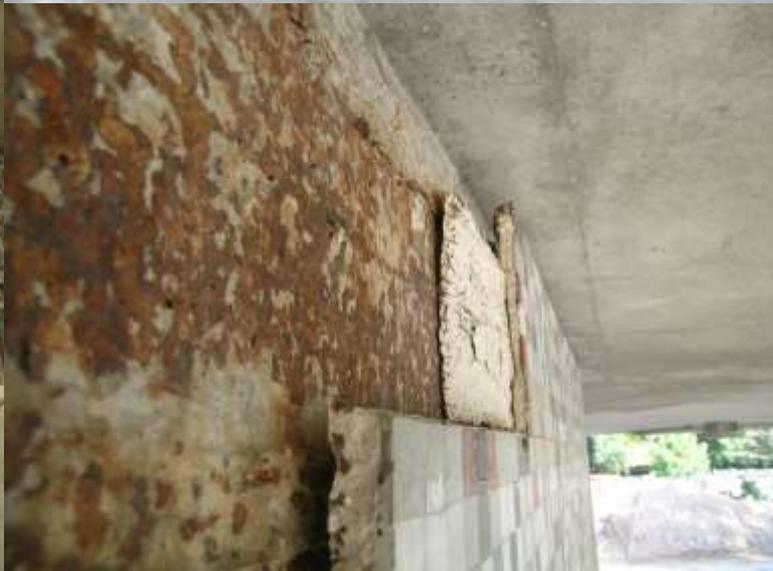
Italian mosaic glass tiles – fascia

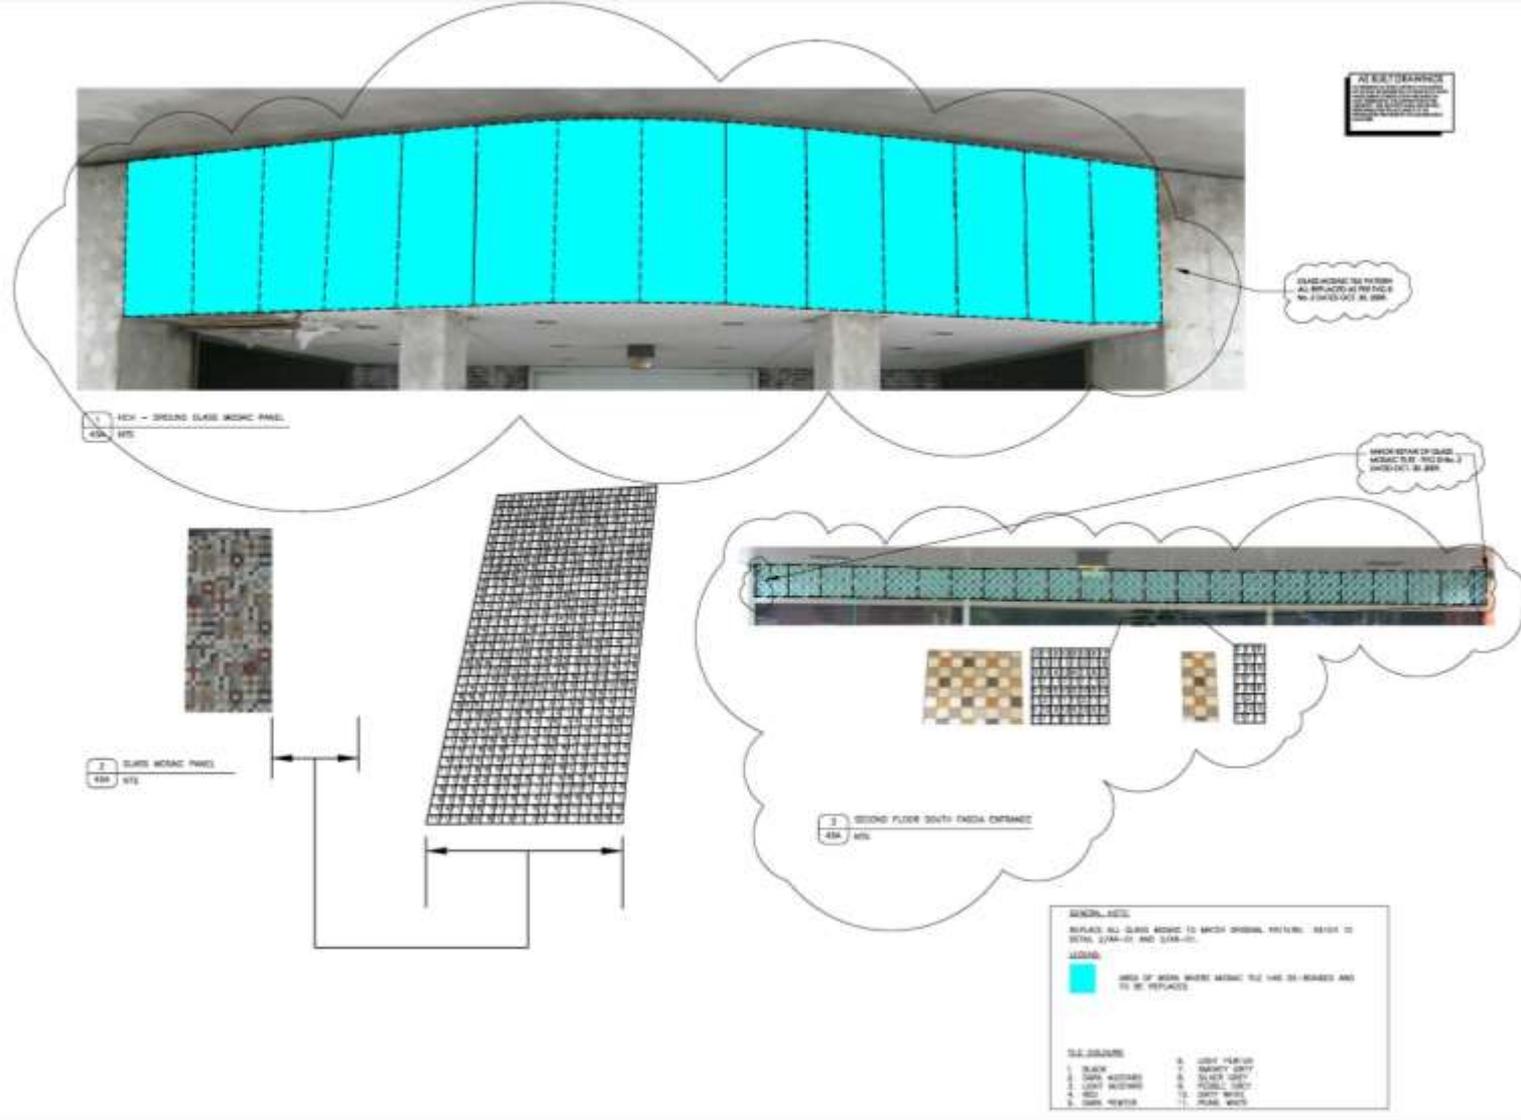
Italian mosaic glass tiles – fascia
